# Manhole Inspection Summary

Manhole # S31AA\_027MH

Insp Date: **1/27/08 1:58 PM**

**Location** Address: **829 LINDEN AVE**

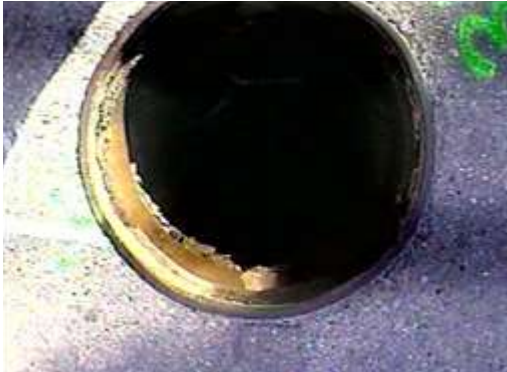
Top View

**Frame** Offset: **2** (in.) Condition: ☒ Sound ☐ Cracked ☐ Leaks

frame offset

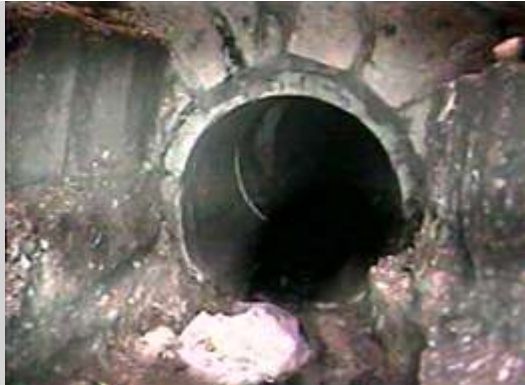
12 O'Clock Outflow

8 in. Circular Gravity Sewer  
Pipe Out @ 12 O'Clock

Pipe Height: (in.) Direct  
Pipe Material: **Clay** ☐ Pipe Lined  
Invert Depth: **10.35** (ft.) Flow Characteristics: **Slow**  
Deposits: ☒ None ☐ Mud ☐ Sludge ☐ Debris ☐ Grease  
Silt Depth: (in.) Deposits Extent:  
Infiltration: **None** Pipe Seal Cond: **Sound**

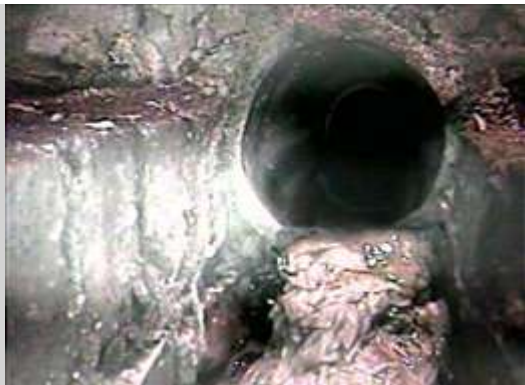
9 O'Clock Inflow

6 in. Circular Gravity Sewer  
Pipe In @ 9 O'Clock

Pipe Height: (in.) Direct  
Pipe Material: **Clay** ☐ Pipe Lined  
Invert Depth: **10.10** (ft.) Flow Characteristics: **Slow**  
Deposits: ☒ None ☐ Mud ☐ Sludge ☐ Debris ☐ Grease  
Silt Depth: (in.) Deposits Extent:  
Infiltration: **None** Pipe Seal Cond: **Sound**
